DAM AND CANYON FACILITIES MASTER PLAN (PHASE 1)

DAM AND CANYON FACILITIES MASTER PLAN MESA COUNTY, COLORADO

August 1, 2016

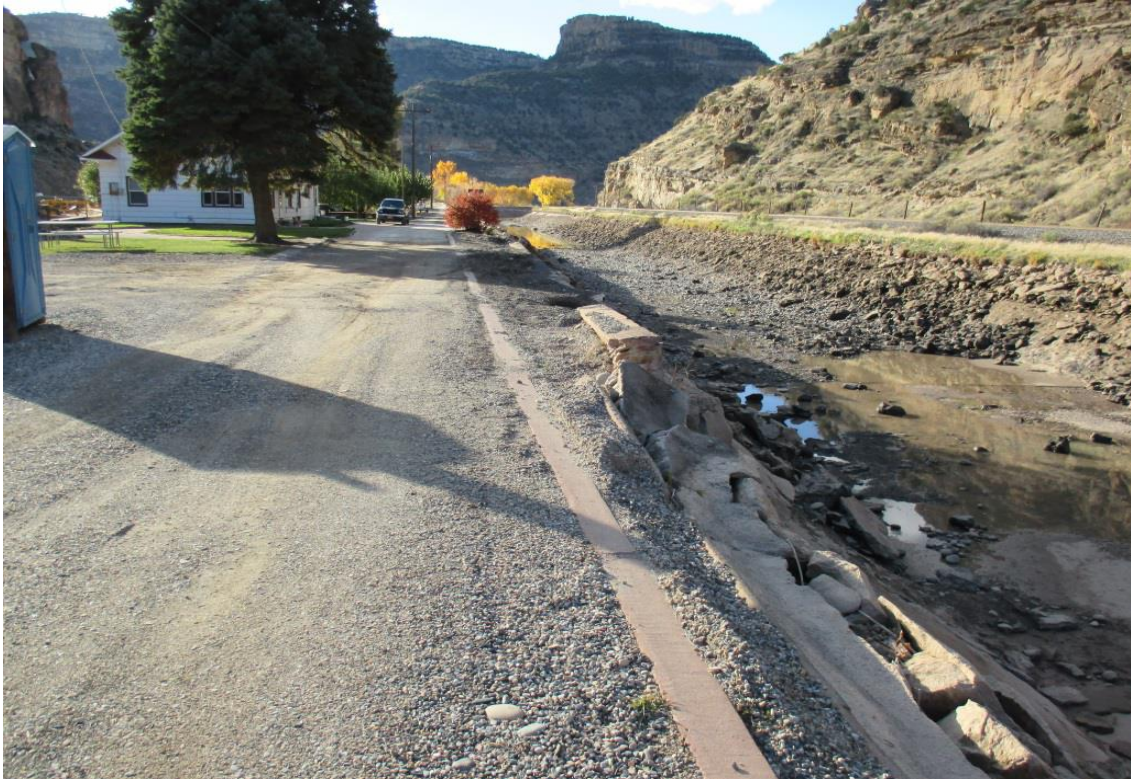
The embankment immediately below the Roller Dam is relatively narrow and separates the Canyon Canal from the Colorado River (Figure 1 and Figure 2). This section of canal was constructed between 1913 and 1915. Over the last 100 years, the embankment has sloughed, settled and degraded. Water has induced piping erosion within the embankment which has led to material loss and sinkholes. This process has caused further destabilization of the area and has most likely contributed to some of the sloughing. Over the years, measures have been taken to control and prevent these processes from escalating. One such action, which can still be observed, is shotcrete lining along the side slope. This solution was temporary as the movement of the bank has continued and led to cracking and displacement of the shotcrete, resulting in a reduced canal cross section. In addition, the degraded shotcrete, as well as displaced masonry stone and riprap, has created a very rough surface which restricts water flow. The combination of the reduced cross section and roughened surface has created a “choke” in the conveyance of water in the canal.

Figure 1. General setting and existing condition of the top 500 feet of the Canyon Canal; looking down canal.

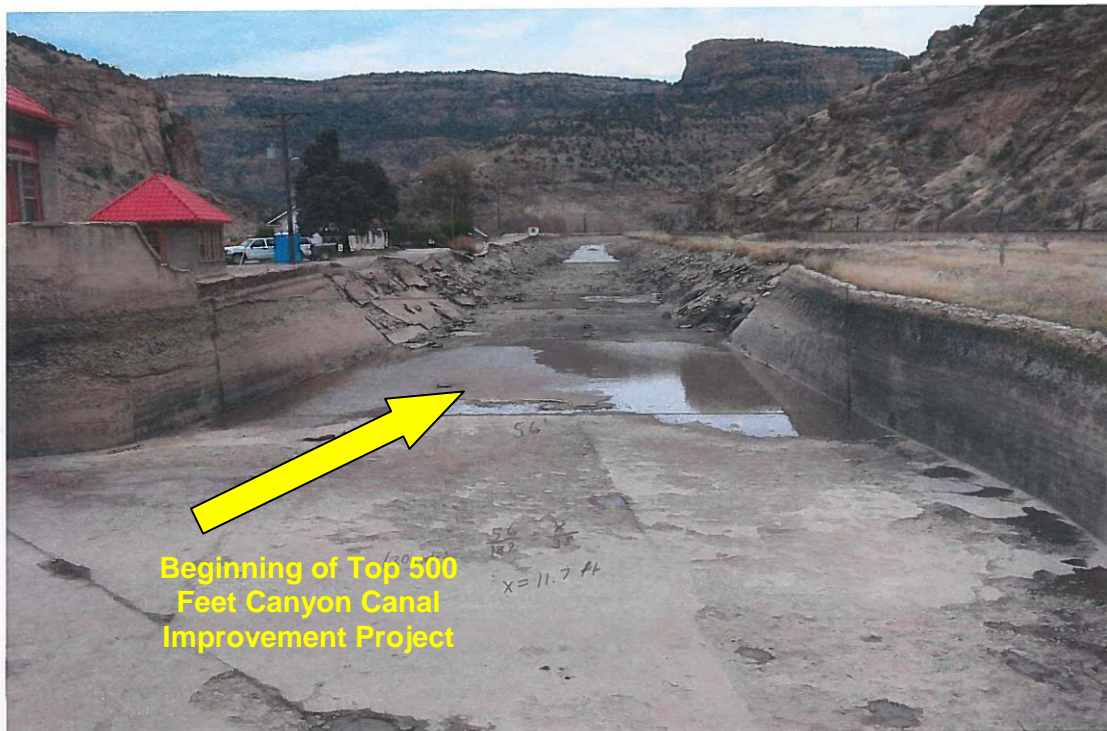
Figure 2. General setting and existing condition of the top 500 feet of the Canyon Canal; looking down canal.

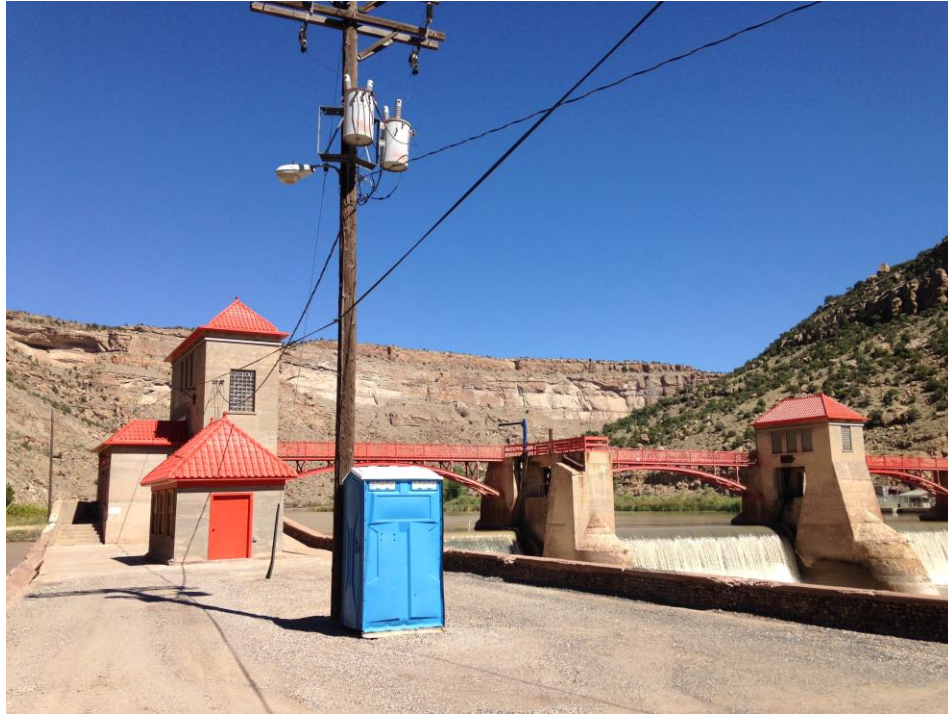
Figure 4. View of existing overhead power lines and the limited space for machinery mobility during mandatory repairs or maintenance on the Dam or canal headworks.

- 1) Bury overhead powerlines: The overhead powerlines will need to be buried if they were not already as part of the canal lining project. This activity will need to take place first as part of the electrical upgrades project. Approximately 800 feet of wire needs to be buried starting at the existing power lines south of the Float House to the dam power house at the right abutment. A new transformer will also be installed. Telephone lines would also be relocated underground (Figure 4).
- 2) Replace service box: A new service box and breakers will be installed to replace the old fuse boxes. The new box will meet the current code requirements, improve safety for the operators and provide flexibility to add other circuits as needed.

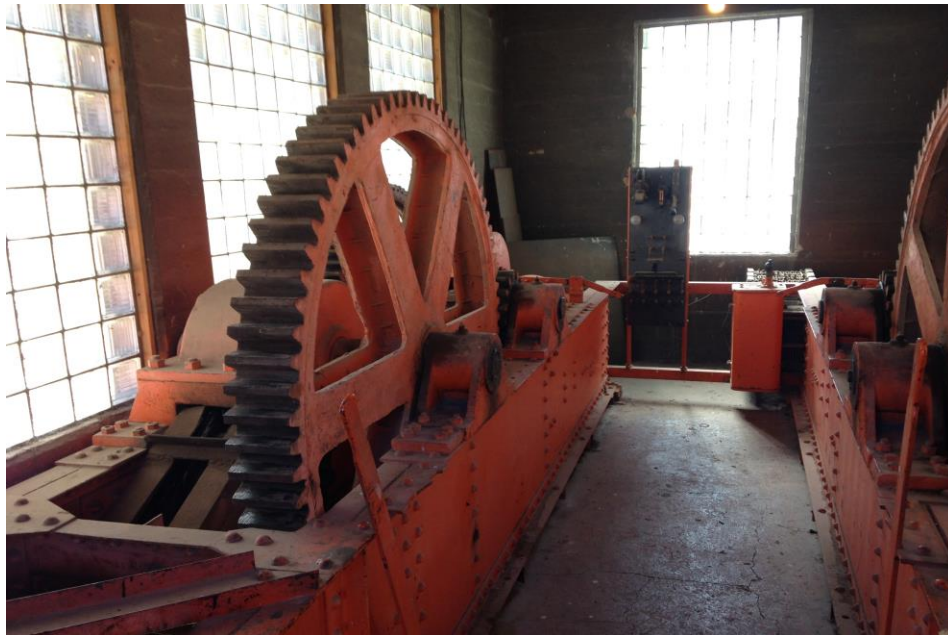
Figure 5. Existing outdated transfer switches and circuit breaker for diversion dam roller gates.

- 3) Rewire Canal headgate controls: The need for wiring will depend on the status and/or planning progress of the Rehabilitation of the Canal Headworks project (Priority 3). Proper wiring would need to be added allow each headgate to operate individually. However, should the operations remain the same; the wiring will be replaced to the drive motor, limit switches and the control wiring from the Float House. Upgrading the wiring will bring the headgate controls into code compliance and will lead to increased operational efficiencies as canal flows could be measured and controlled more closely (Figure 5 and Figure 6 and Figure 8).

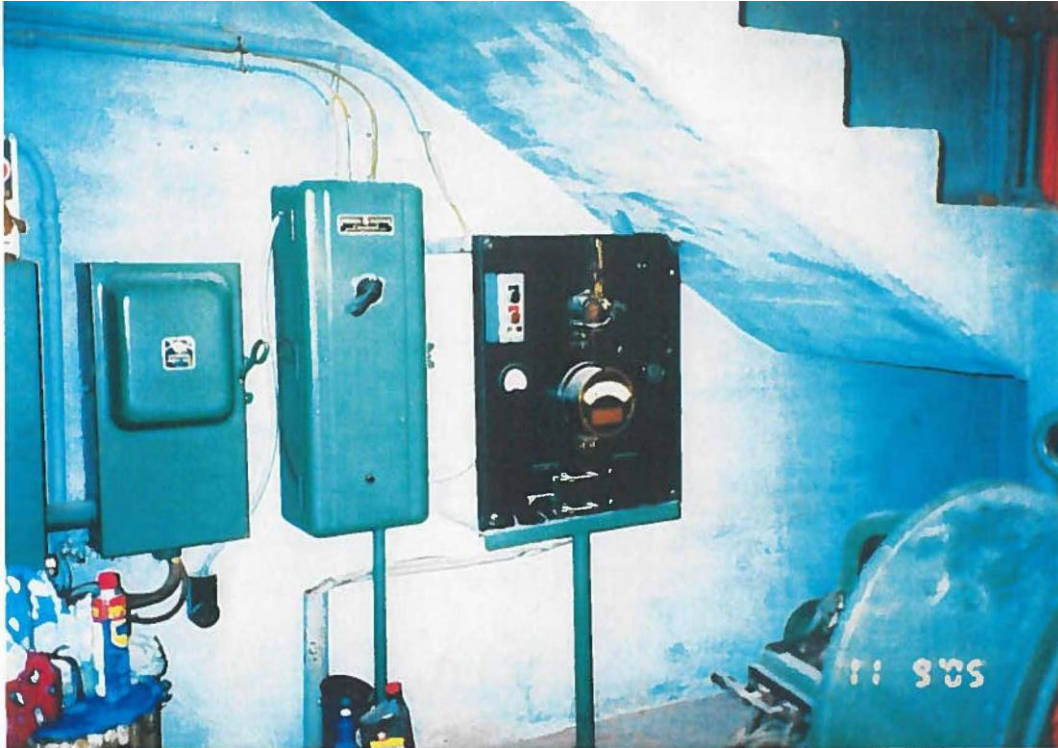
Figure 6. Switch and breaker panels and on/off push button switch (on black panel) for DC power to Grand Valley Diversion Dam, located in power house on the right abutment. Grand Valley Diversion Dam RO&M Exam, Grand Valley Project; November 9, 2005.

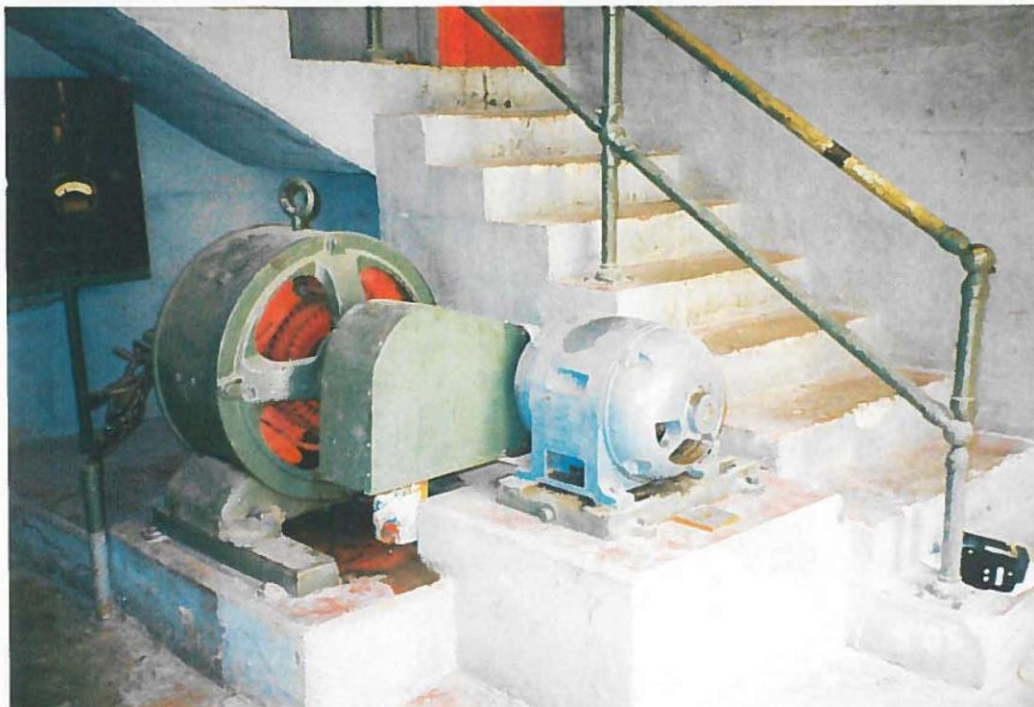
Figure 7. AC motor (gray) for the DC generator that provides electrical power to roller gate hoists on the Grand Valley Diversion Dam. Grand Valley Diversion Dam RO&M Exam, Grand Valley Project; November 9, 2005.

- 4) Replace Roller Dam wiring and upgrade electrical system: The wiring across the Roller Dam to each roller will be replaced to meet code requirements. More outlets and lighting may also be added, including 220 volt welder plugs, to facilitate easier maintenance and safety during night operations. Changing to AC power to operate the Rollers will be also be considered and evaluated (Figure 7).

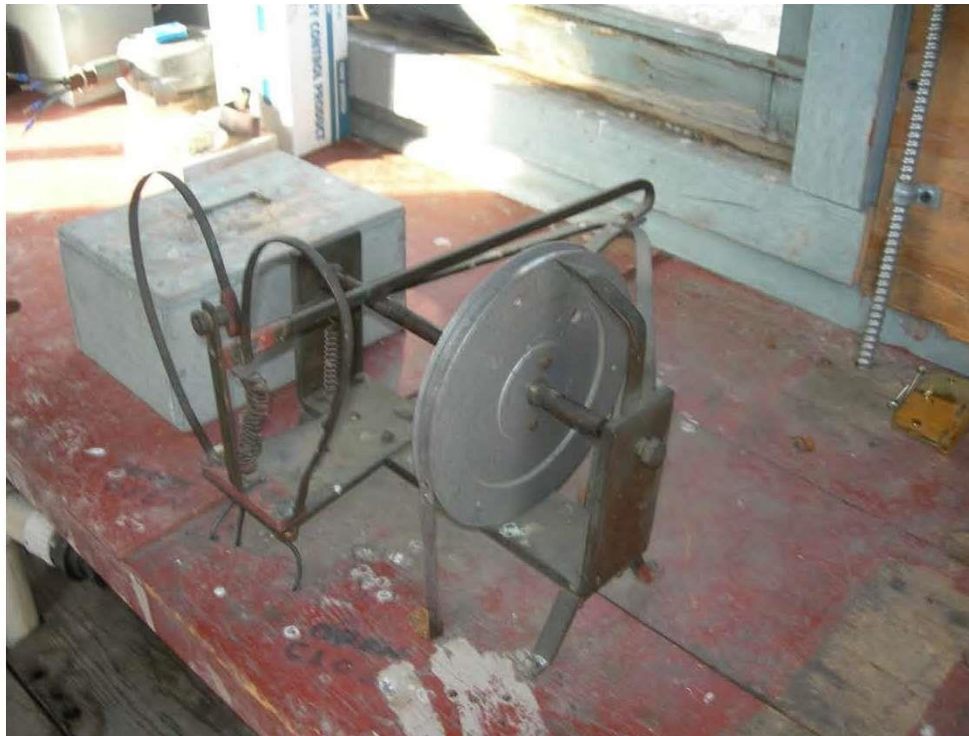
Figure 8. Automation mechanism that regulates flow in canal. Grand Valley Diversion Dam RO&M Exam, Grand Valley Project; November 28, 2011.

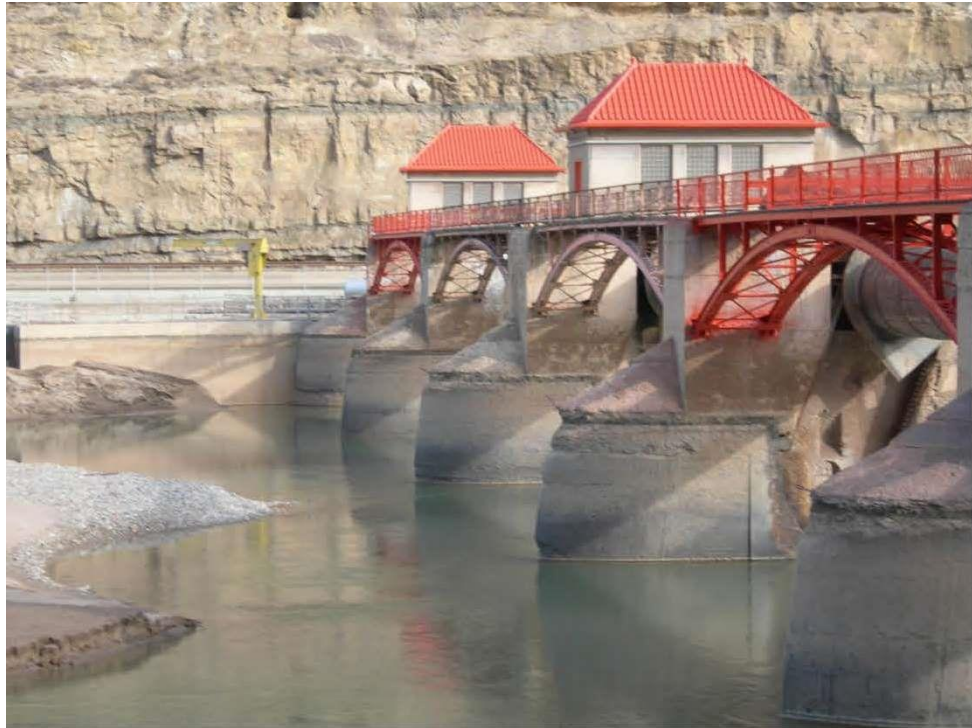
The 1987 and 2011 BOR RO&M reports indicate that the concrete on the piers supporting the rollers is severely weathered, and in some locations, eroded from the face of the piers exposing the reinforcement (Figure 9). The top of the rollers, where the river flow contacts the face of the pier immediately after flowing over the top of the gate, has shown the most severe indications of erosion as flow passes over the gates for a majority of the year when the roller gates are in the down position. The erosion is most likely caused by the dynamic force of the water infiltrating the concrete, and the subsequent freeze/thaw action that occurs during the winter months. Additionally, once water has penetrated the concrete over a period of time, corrosion of reinforcement takes place, which then expands and spalls the concrete.

Figure 9. Weathered concrete along upstream footers of Roller Dam. Grand Valley Diversion Dam RO&M Exam, Grand Valley Project; November 28, 2011.

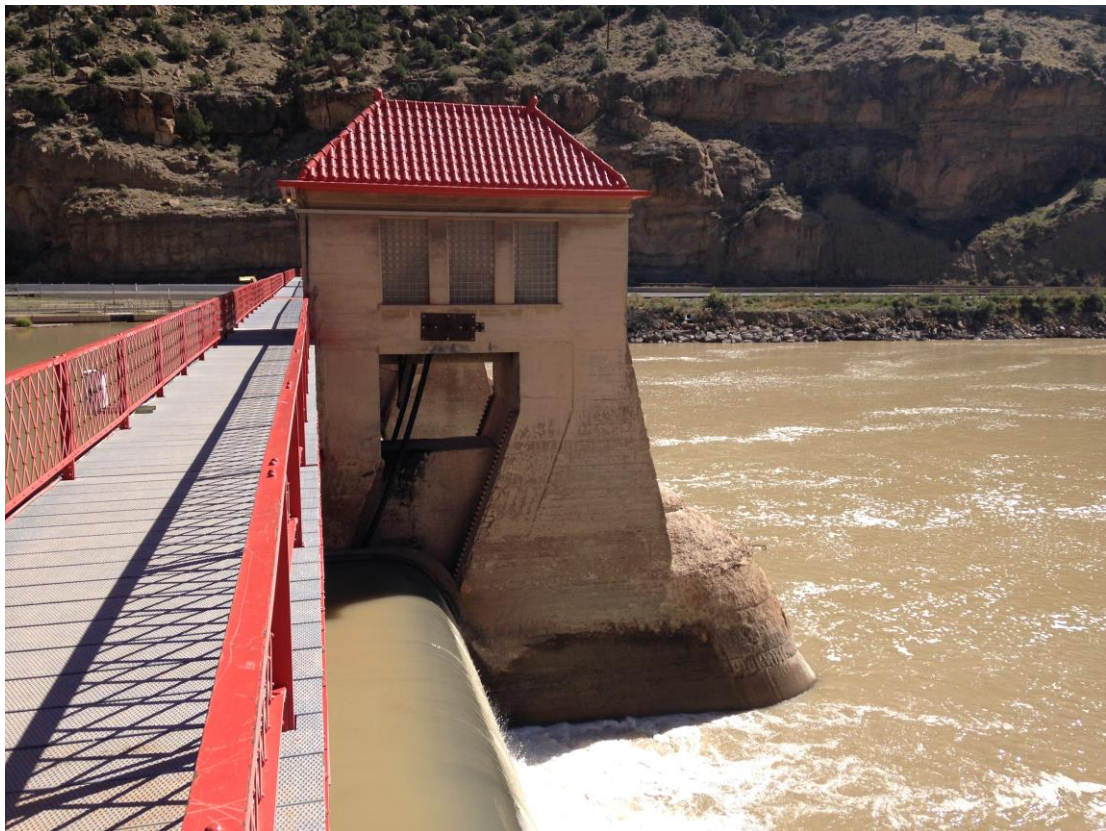
Spalling is occurring near the downstream bearing of the roller track (Figure 10 and Figure 11). The track is anchored to the face of the concrete by pairs of bolts spaced 8” to 12” along the almost vertical path of the roller (Figure 12). The roller is supported vertically by the drive chain on the upstream side, and the track on the downstream side (Figure 13). The hydraulic force on the upstream face of the roller drives the roller into the pier at this support. A complete concrete failure that could impact the end of the roller support is highly

Figure 10. Weathered concrete surface on the downstream side Roller Dam tower.

The repair of these eroded areas would consist of removal of all loose concrete to a depth at least 1" beyond the back face of the existing reinforcement. The method that would be most efficient in this case would be hydro demolition, which removes concrete with high-pressure water. The repair area is estimated to be 2 feet wide by 24 feet long, which is adjacent to the full length of the roller track. During the demolition, concrete would be removed to sound concrete, and may be more or less than 24" wide by 5" deep (Figure 14). Edges of the removal area would be square cut or dovetail cut to provide a clean edge to work to, and to facilitate anchorage to the existing concrete.

Existing reinforcement would be blast cleaned to remove all corrosion, then coated with a corrosion inhibitor. New epoxy coated reinforcing would be installed to lap with the existing. The reinforcement would be #3 dowels, 12" on center, with a 4" leg drilled and epoxied in-place 2" clear of the track base. The leg of the dowel would be installed to avoid the existing track bolt embedment region.

New concrete would be placed by the shotcrete method, which requires no formwork, and allows installation of the material at a very low water/cement ratio, thereby reducing shrinkage and the possibility of future cracking. The final surface would be screeded to achieve the profile, followed by steel troweling to provide a smooth surface. Following the

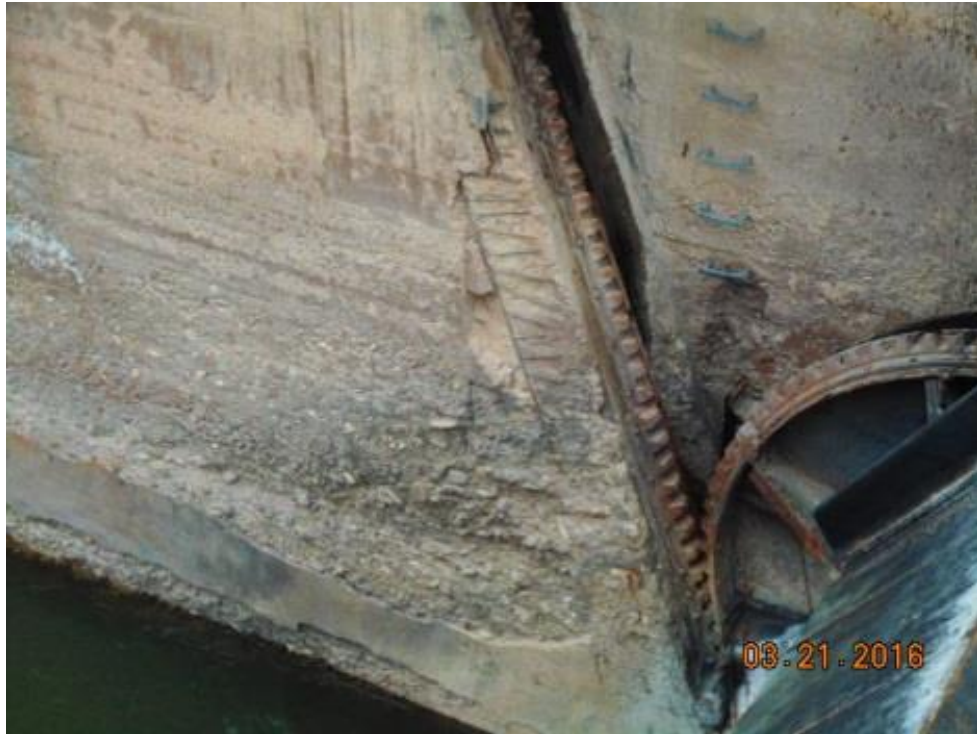
Figure 11. Spalling near the downstream bearing of the roller track (typical).

unlikely in the near future under the existing conditions (with approximately 3" and cracking is noted between the remaining face of concrete and the edge of the track); however, continued spalling affecting the alignment of the track is much more likely in the next several years if the concrete is not repaired and could potentially prevent operation of the roller.

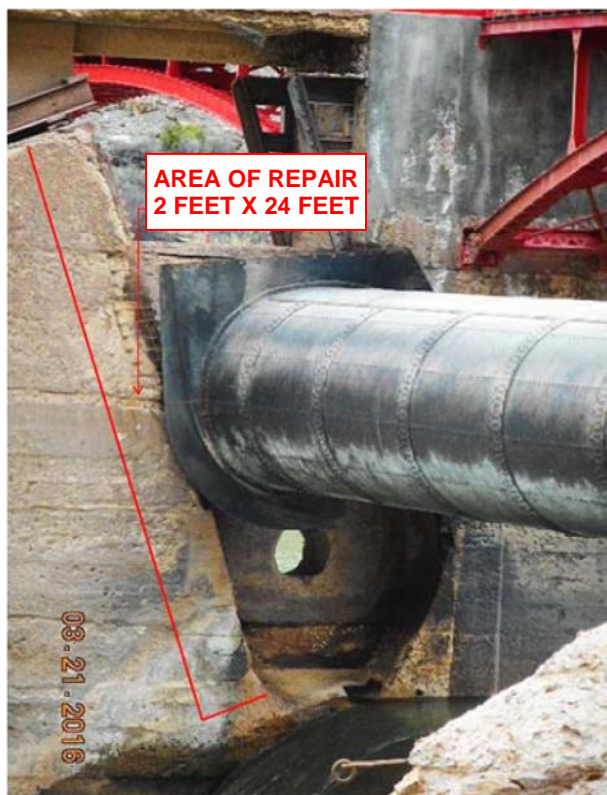
Figure 14. Approximate area of repair, which will be excavated to a 5" depth.

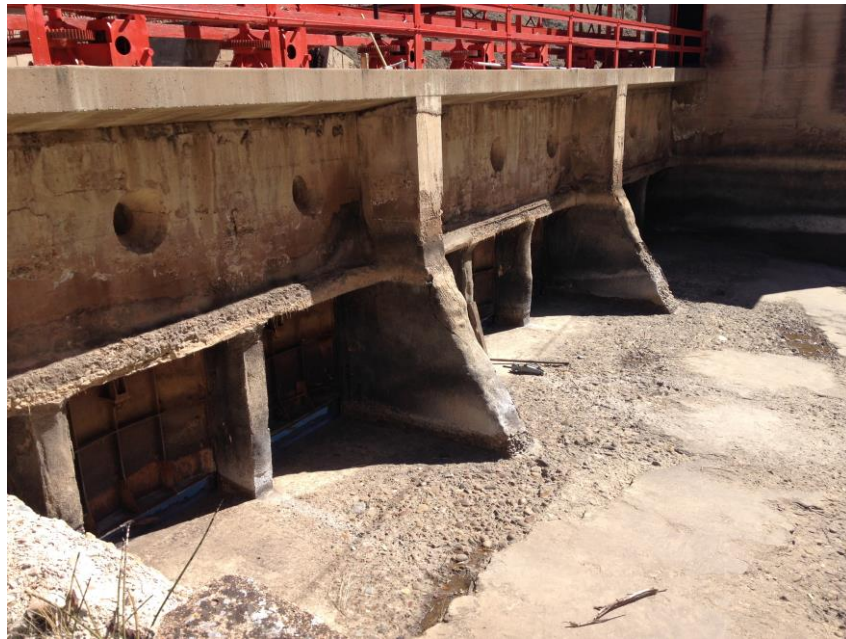
Figure 15. Canal Headgate Structure, downstream side needing concrete repair. Remaining shotcrete from previous rehabilitation efforts can be seen on the support piers.

Similar to the Roller Dam roller track rehabilitation the canal transition zone will consist of hydro demolition to remove all loose concrete to a depth of 1-2 inches beyond the existing surface. A polymer modified repair mortar (SikaRepair 224) will be placed in the exposed areas. The Mortar can be trowel or sprayed and is enhanced with silica fume and fibers for increased density, abrasion resistance and compressive strength. The recommended mortar has very good freeze thaw values. The mortar mix was selected to address the spalling problems historically impacting the canal transition concrete. Once applied, the mortar will be finished with a smooth trowel to aid in the high capacity required of the canal.

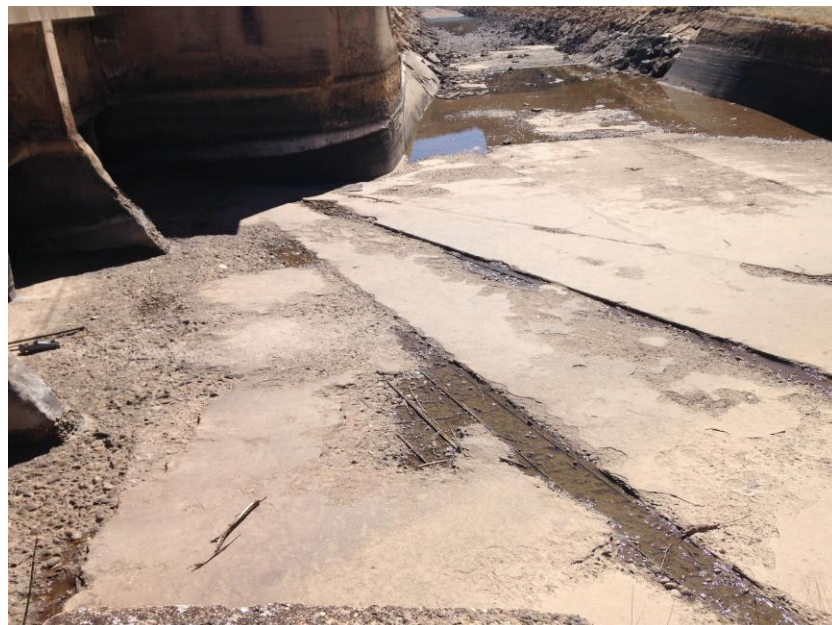
- 1) Areas of the floor have severe weathering and exposed rebar. Rehabilitation is needed on approximately 950 square feet.
- 2) The canal walls in the transition are weathered near the full flow water surface elevation where freeze/thaw has occurred. Rehabilitation of the canal walls is needed across approximately 1,140 square feet. In addition to the rehabilitation efforts, a concrete cap is being proposed along the north wall to provide two feet of freeboard and limit the opportunity for canal water to leak over and behind the existing canal wall.
- 3) The downstream side of the canal headgates headwall concrete is showing signs of freeze/thaw weathering despite previous efforts to shotcrete eroded areas. Rehabilitation of the canal headgate concrete is needed for approximately 1,560 square feet.

Three areas of the canal transition zone will be repaired including the canal floor, canal walls and the backside of the canal headgate. Rehabilitation efforts have occurred in the area including an application of shotcrete that partially remains in some areas (Figure 15). However, the shotcrete has mostly been eroded in all areas and original concrete and sometimes the supporting rebar is visible (Figure 16 and Figure 17).

Figure 16. Canal transition zone flooring with observed spalling and exposed rebar.

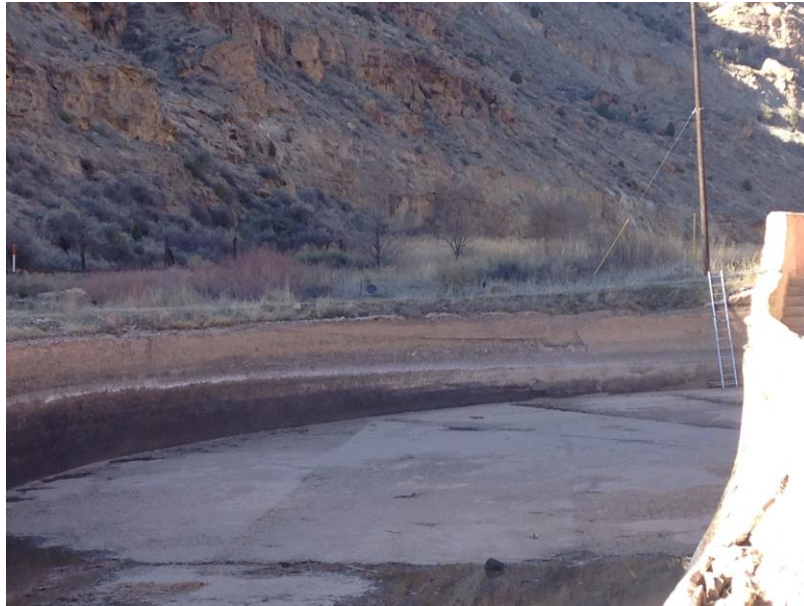
Figure 17. Canal transition zone walls with observed spalling near the top of the wall and near the winter water surface elevations.

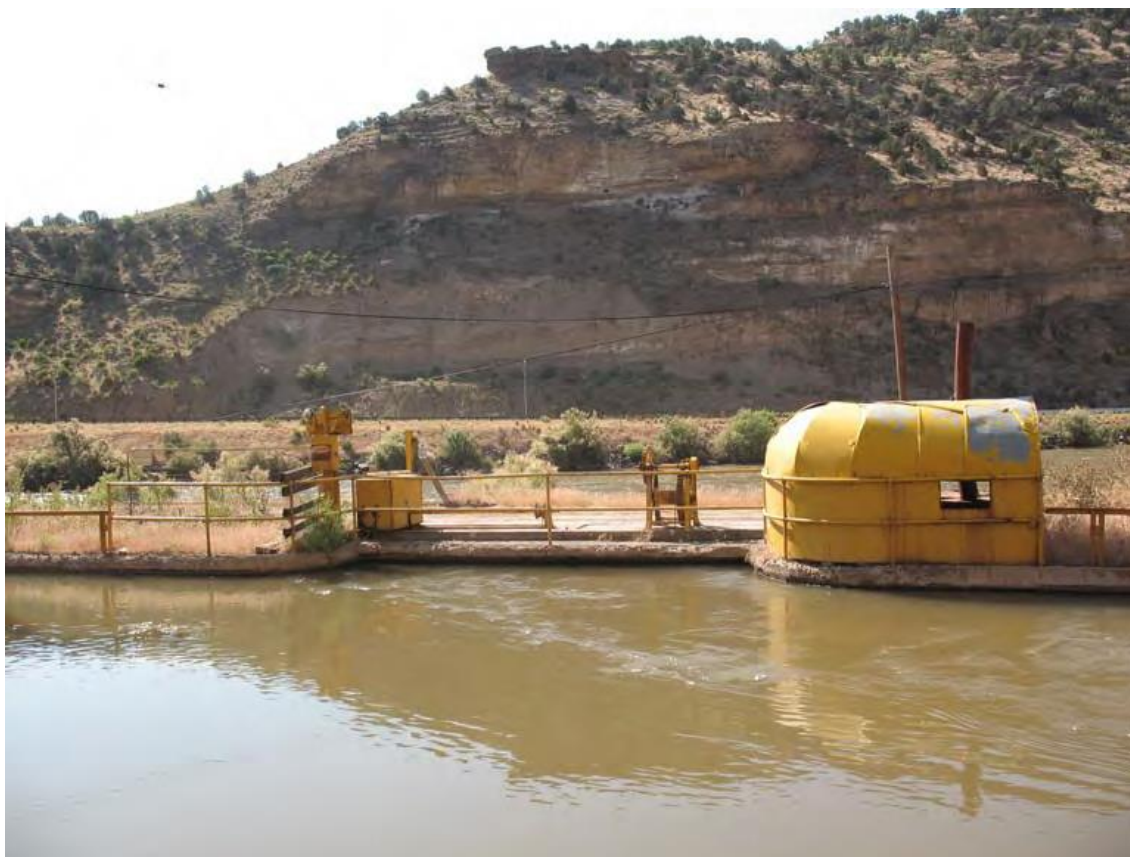
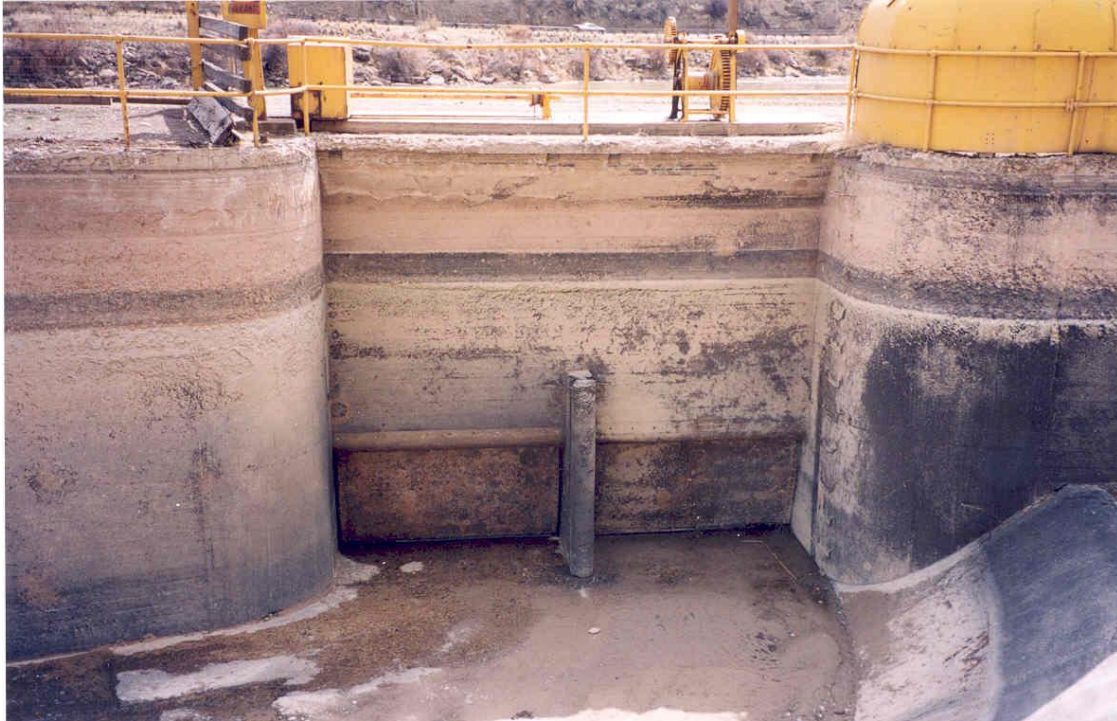
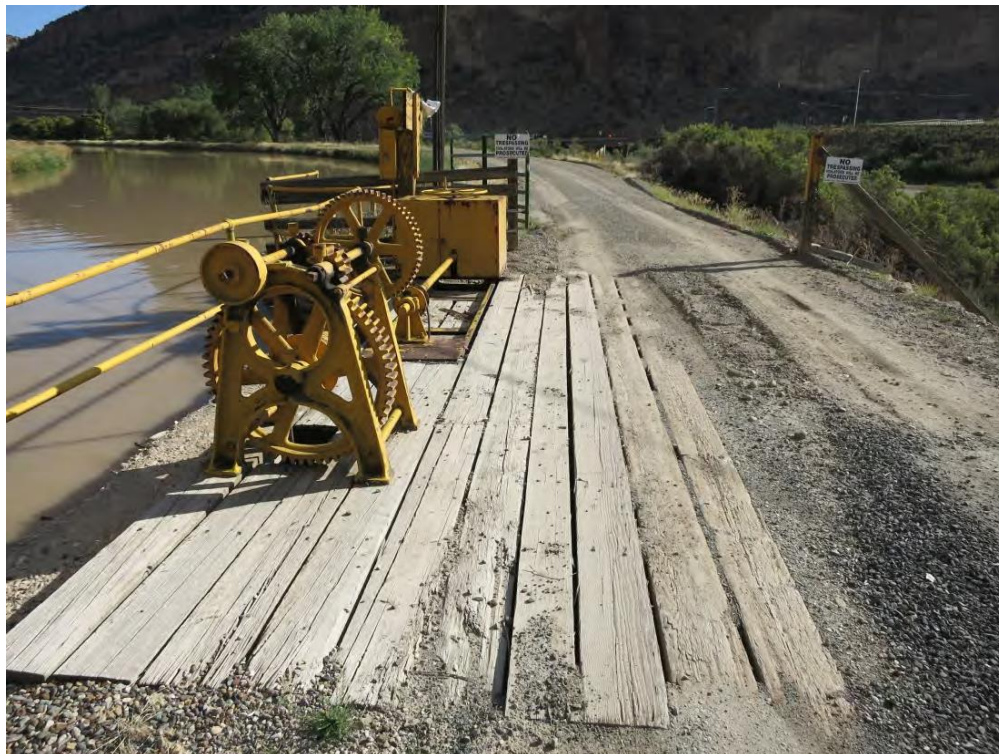
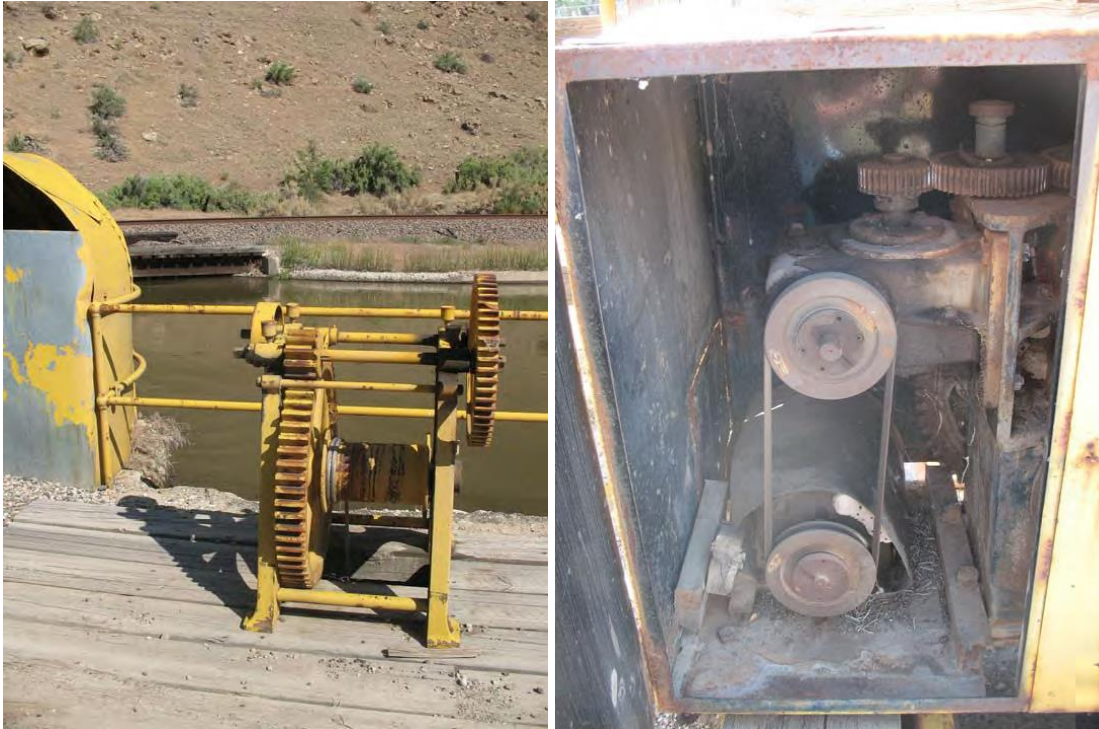
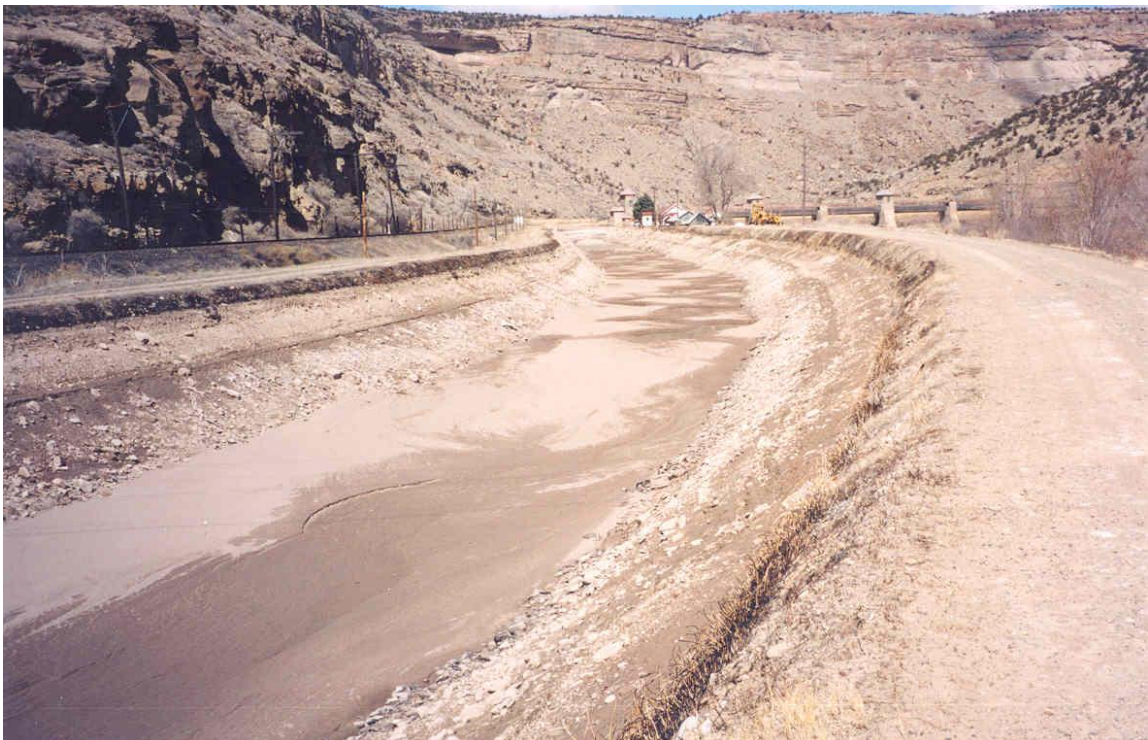
The radial gates need to be replaced in order to keep the Station 22 spillway functional. The frames supporting both radial gates are rusting out requiring the gates to be completely rebuilt or replaced with a more modern design. Each gate is uniquely designed and will require a review of the historical drawings and reissued before a local craftsman can rebuild them. More modern replacement options such as vertical lift gates could be used and will be easier to maintain in the future.

Additional design considerations will also be needed to evaluate options for preventing ice buildup on the gates to make sure they remain operational throughout the winter. Further design is needed to update the crude electric hoists on one radial gate and the hand operated hoist for the other gate. Upgrading the hoists will allow for more accurate and efficient operations of the gates especially during an emergency situation. See Figure 18 through Figure 22.

The first step of this project is to prepare a preliminary design for the replacement of the radial gates framework, update the gate hoists and consider how to mitigate winter ice buildup issues. An assessment of varying options may be included as part of the preliminary design. Final design and implementation of the design will follow once funding has been secured.
