DAM AND CANYON FACILITIES MASTER PLAN (PHASE 1)

DAM AND CANYON FACILITIES MASTER PLAN MESA COUNTY, COLORADO

August 1, 2016

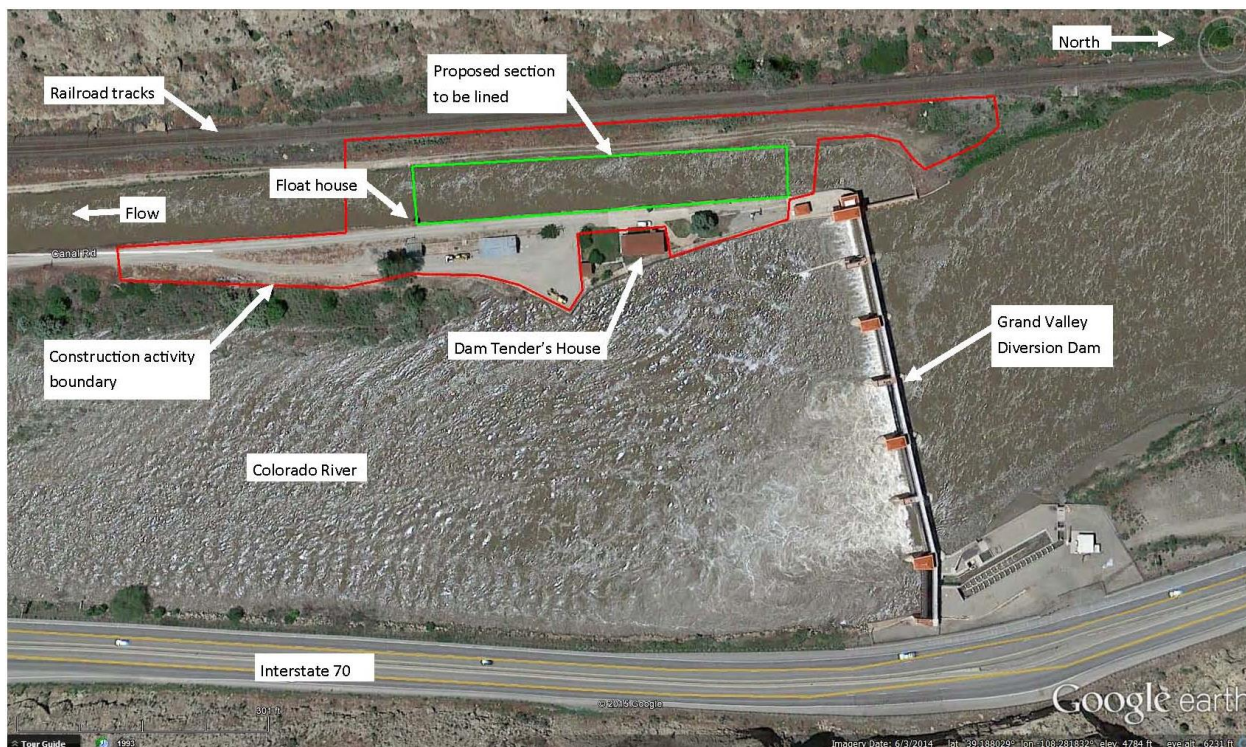
Two conceptual designs were developed by Reclamation for this project. Both designs begin where the concrete transition structure of the Roller Dam terminates and end at the float-house structure approximately 500 feet downstream of the transition structure (Figure 3).

Figure 3. Aerial View of the Roller Dam (Grand Valley Diversion Dam) and Top 500 Feet of the Canyon Canal to be Lined.

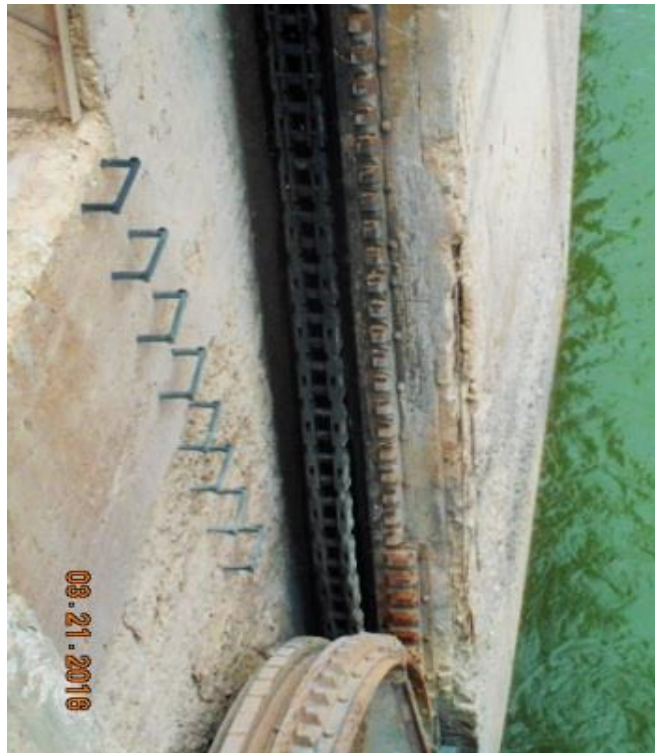
Spalling is occurring near the downstream bearing of the roller track (Figure 10 and Figure 11). The track is anchored to the face of the concrete by pairs of bolts spaced 8” to 12” along the almost vertical path of the roller (Figure 12). The roller is supported vertically by the drive chain on the upstream side, and the track on the downstream side (Figure 13). The hydraulic force on the upstream face of the roller drives the roller into the pier at this support. A complete concrete failure that could impact the end of the roller support is highly

Figure 12. Bolt connections to the vertical path of the rollers.

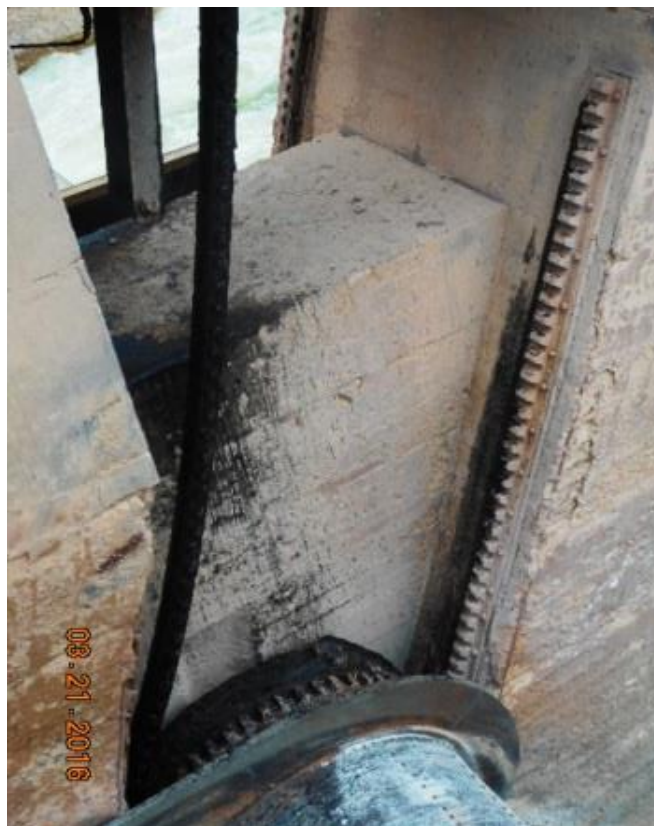
Figure 13. Drive chain (upstream) and track (downstream).

unlikely in the near future under the existing conditions (with approximately 3" and cracking is noted between the remaining face of concrete and the edge of the track); however, continued spalling affecting the alignment of the track is much more likely in the next several years if the concrete is not repaired and could potentially prevent operation of the roller.
